# Manhole Inspection Summary

Manhole # S37E\_\_027MH

Insp Date: **11/18/08 12:51 PM**

**Location** Address: **407 saratoga st**

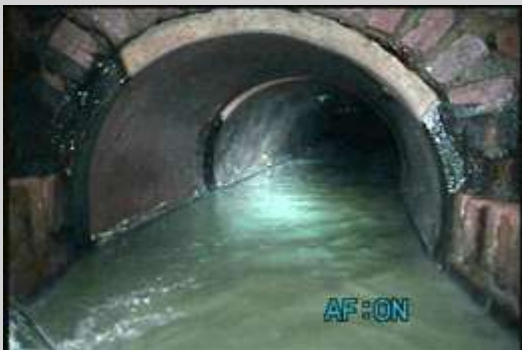
12 O'Clock Outflow

24 in. Circular Gravity Sewer  
Pipe Out @ 12 O'Clock

Pipe Material: **Clay** ☐ Pipe Lined

Invert Depth: **13.33** (ft.) Flow Characteristics: **Fast**

Infiltration: **None**

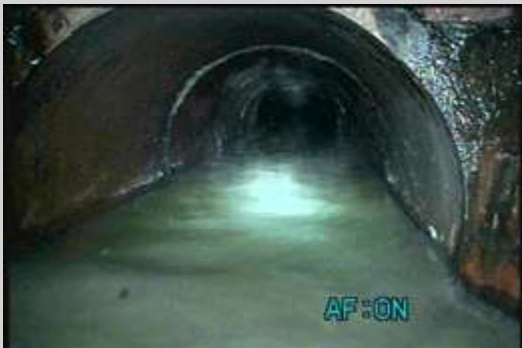
6 O'Clock Inflow

24 in. Circular Gravity Sewer  
Pipe In @ 6 O'Clock

Pipe Material: **Clay** ☐ Pipe Lined

Invert Depth: **13.29** (ft.) Flow Characteristics: **Fast**

Infiltration: **None**

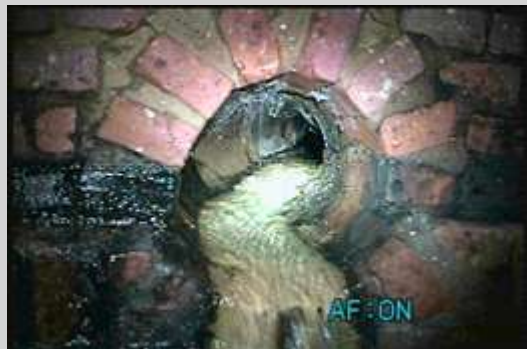
9 O'Clock Inflow

8 in. Circular Gravity Sewer

Pipe In @ 9 O'Clock

Pipe Material: **Clay** ☐ Pipe Lined

Infiltration: **None** Pipe Seal Cond: **Unknown**
